BMW of North America, Inc.

RE: Recall Campaign - Seat Backrest
2000 BMW R 1200 C Motorcycles

00V-289 (6)

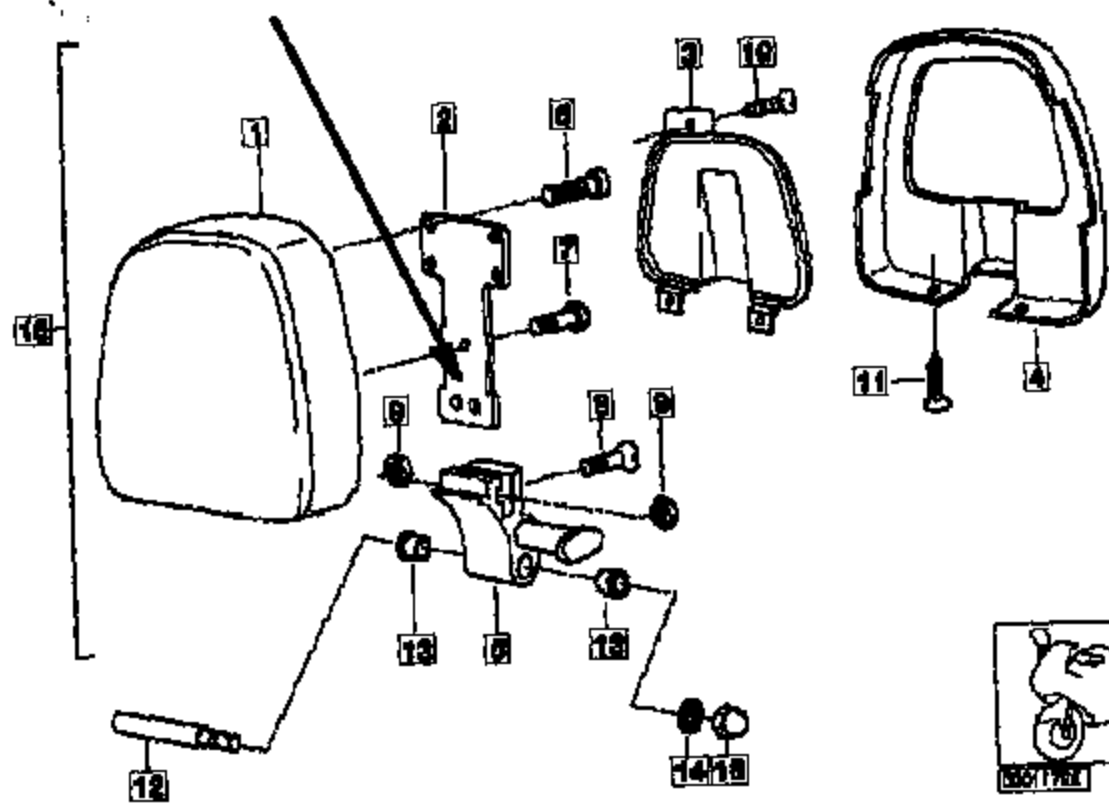
The backrest contains a leaf spring mounting bracket, which connects the backrest cushion to the adjusting bracket (see attached drawing). It is possible for the mounting bracket, if overloaded with the backrest in

the vertical position, to crack or break. If the bracket were to break, the backrest would detach from its mount.

The bracket design had previously been changed from one using round mounting holes to the current design with square mounting holes and pressed-in nuts.

6. BMW became aware of the problem as a result of field reports indicating a total of 13 cases worldwide (6 in the US) involving breakage of the backrest mounting bracket. In two of the cases (including one in the US), minor injuries were reported due to the rider's balance being affected. Subsequent analysis has determined that the square-hole design results in an increased notch effect at the corners of the holes, which can lead to breakage of the bracket if it is overloaded.

7. Not applicable
8. BMW will conduct a recall campaign to remedy the potential defect in the affected vehicles. The remedy will consist of replacing the backrest with one containing the original-design mounting bracket with round holes.
BMW expects to begin and complete the sending of notifications to owners by the end of October 2000.
